REC-ERC-81-7

PERFORMANCE OF GRANULAR SOIL COVERS ON CANALS

**Engineering and Research Center
Bureau of Reclamation**

August 1981

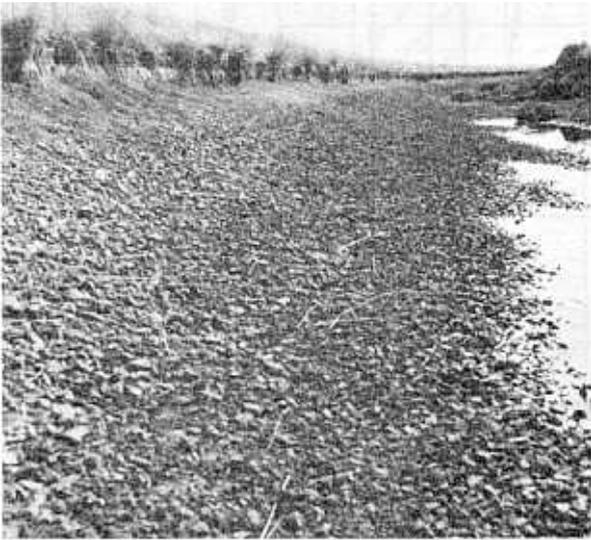
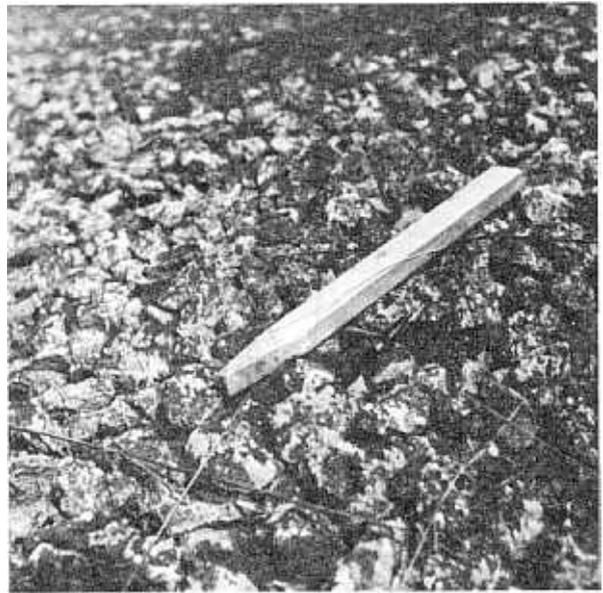
During the inspection of these selected reaches in November 1977, the cover had stabilized and was observed to be in good condition (fig. 3).

Figure 3. — West Canal, 5th Section, looking upstream from station 1080 + 06 m (3543 + 50 ft) (left) with a close view at the same station. November 1977 Photos P801-D-79537 and P801-D-79538

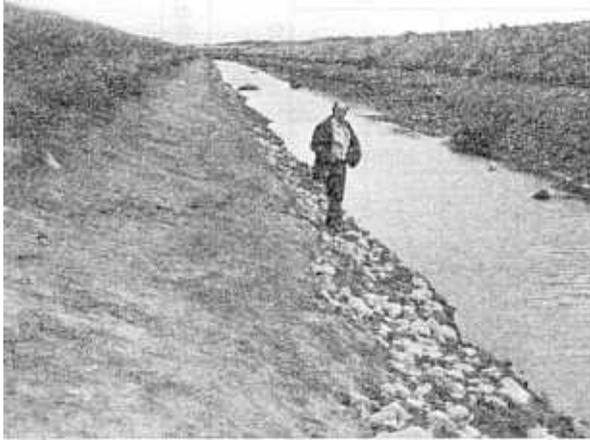
On this lateral there was some slippage of the cover soon after water was first turned in, but there has been none since. Maintenance costs have been very low. An inspection in November 1977 showed that the cover was still in good condition (fig. 5).

Figure 5.—Lateral PE38.9. November 1977 Photo P801-D-79529

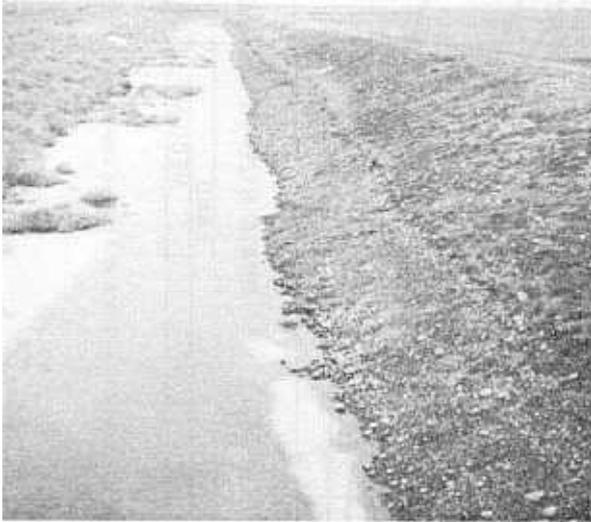
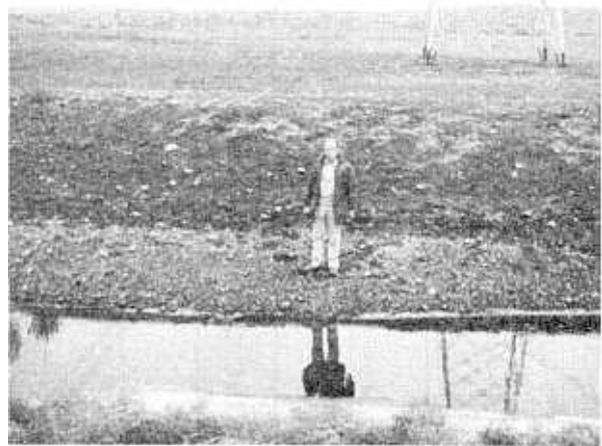
During an inspection in November 1977, the cover appeared to have stabilized and was in fair condition (fig. 7). At the time, there was a considerable amount of water in the lateral.

Figure 7.—Lateral W20, looking downstream from bridge at approximately station 212+84 m (698+30 ft) (left) and upstream (right) from the same station. November 1977 Photos P801-D-79551 and P801-D-79525

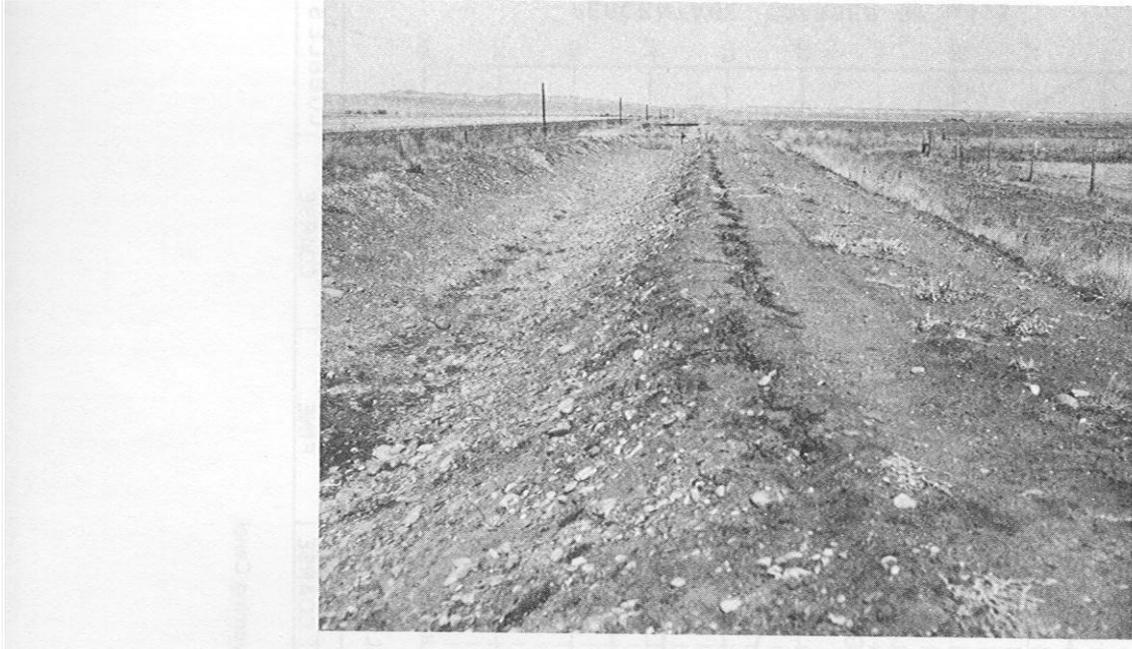
1179+87 ft), and stations 440+82 to 462+31 m (1446+25 to 1516+75 ft), there had been slight slippage of cover materials and some consolidation causing cracks above the waterline at the top of the side slope (fig. 12). However, this was not considered to be serious for reaches between stations 86+36 and 97+51 m (283+32 and 319+90 ft) (fig. 13) and between stations 313+65 and 359+62 m (1029+05 and 1179+87 ft). It was noted that there was evidence of cattle traffic in some areas.

Figure 12.—Angostura Main Canal near station 440 + 84 m (1446 + 32 ft). Typical crack at top of cover from settlement soon after construction. March 1961
Photo P801-D-79528

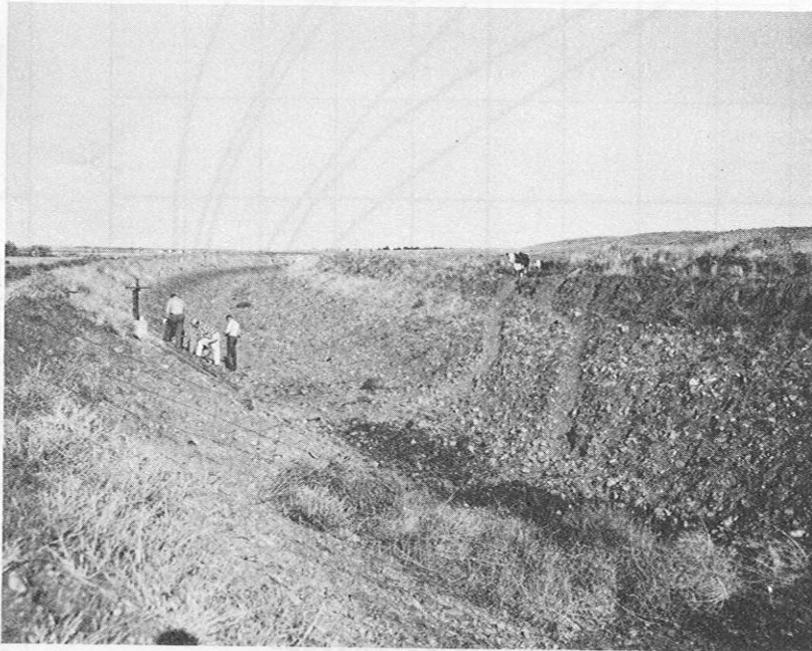
Figure 13.—Angostura Main Canal at station 93 + 12 m (305 + 50 ft) showing effect of cattle traffic on cover for asphalt membrane lining. March 1961
Photo P801-D-79531

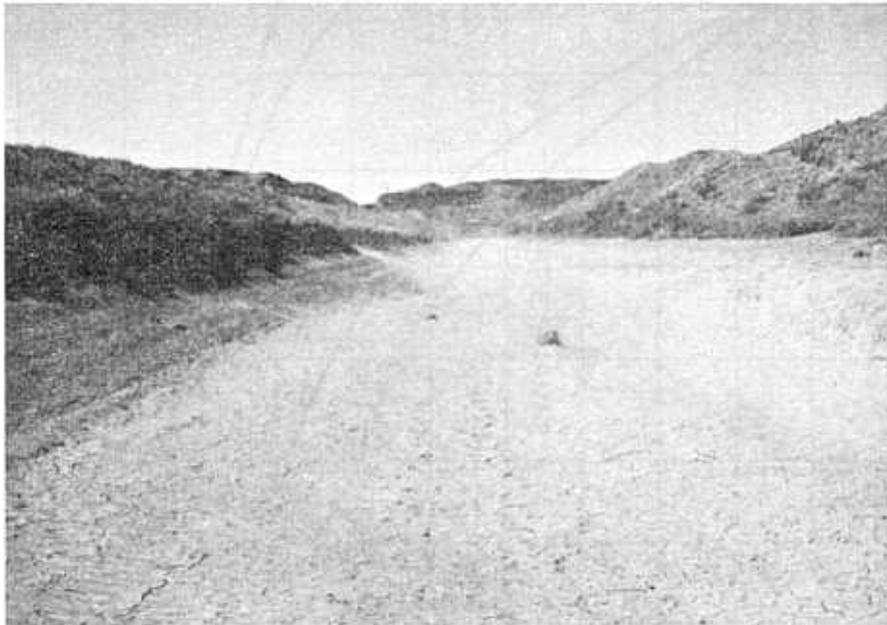
During the inspection of the section between station 568+54 to 569+99 m (1865+28 to 1870+05 ft) in 1960, it was noted that fines had eroded from the cover, and the addition of beach belt material was anticipated. During the April 1978 inspection, this reach was in poor condition (fig. 16).

Figure 16. — Wyoming Canal looking upstream from station 477+01 m (1565+00 ft).
April 1978 Photo P801-D-79533

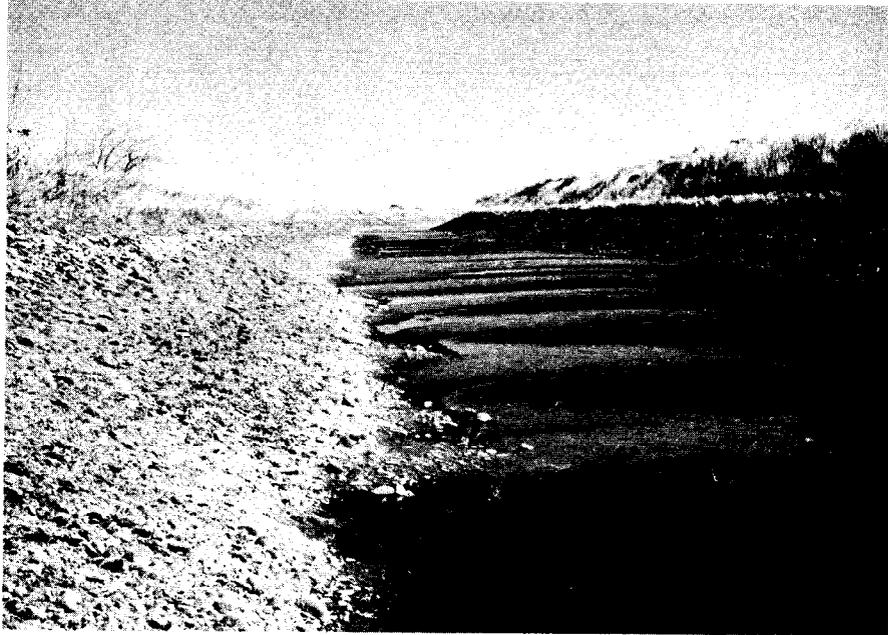
When the cover materials in these canal sections were sampled in November 1960, the covers were reported to be in excellent condition. The fine layer was 200 to 300 mm (8 to 12 in) thick and the coarse layer 175 to 250 mm (7 to 10 in). Also, in April 1978, the covers were reported to be in good condition (figs. 18 and 19), with only some slight bulging at the toe of the slopes.

Figure 18.—Pilot Canal looking downstream from station 95+40 m (313+00 ft). April 1978 Photo P801-D-79532

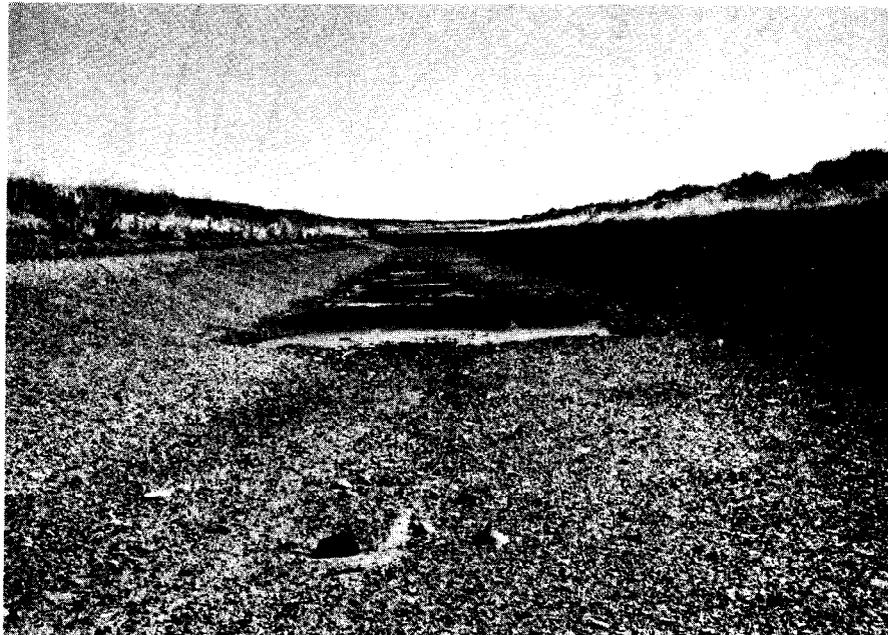
Figure 19.—Pilot Canal looking downstream from station 252+68 m (829+00 ft). April 1978 Photo P801-D-79553

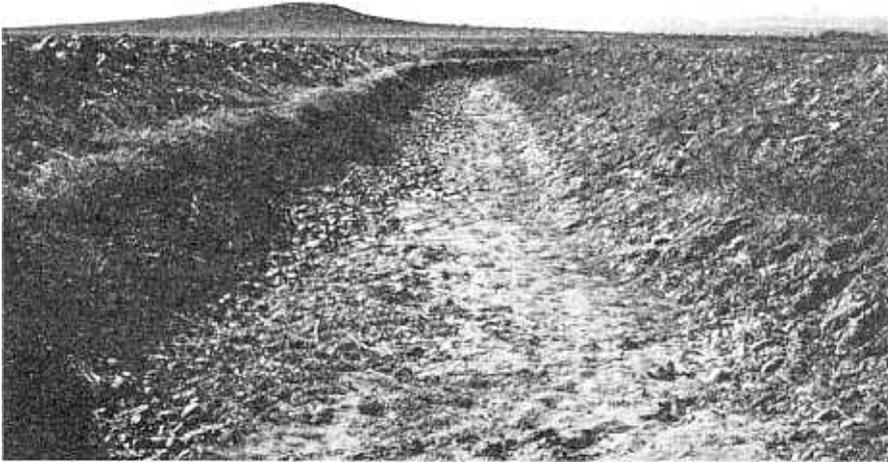
When inspected in April 1978 (figs. 21 and 22), the cover was largely removed from the top half of the canal and deposited in the canal bottom. The lining was exposed and deteriorating in many places. Grass was growing in the top half of the section.

The calculated tractive force of 5.3 to 5.7 N/m² (0.11 to 0.12 lb/ft²) was higher than for the other test reaches on this project and may have been a factor in causing the deterioration of the covers.

Figure 21.—Pavillion Main Lateral, looking upstream from station 124 + 05 m (407 + 00 ft).
April 1978 Photo P801-D-79534

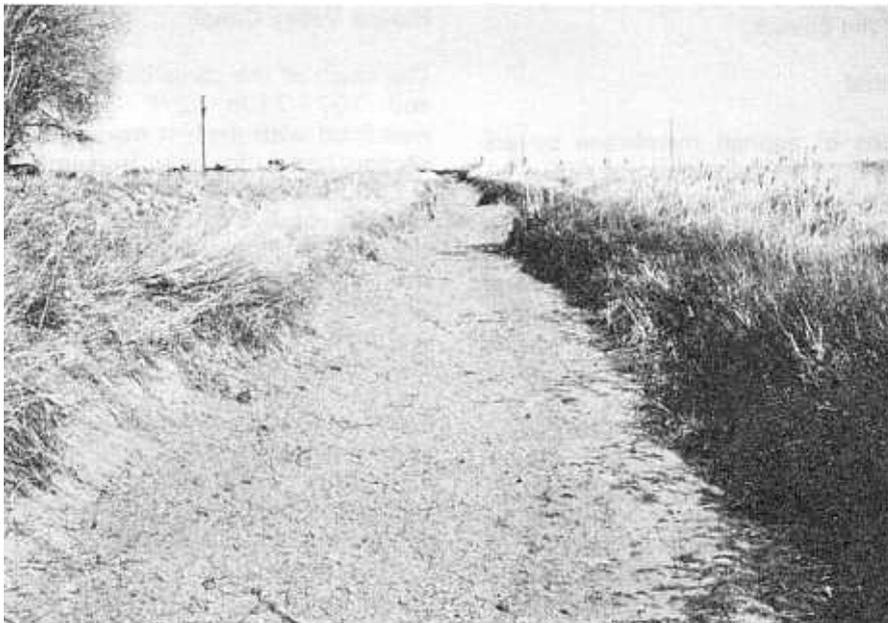
Figure 22.—Pavillion Main Lateral, looking downstream from station 161 + 54 m
(530 + 00 ft). April 1978 Photo P801-D-79535

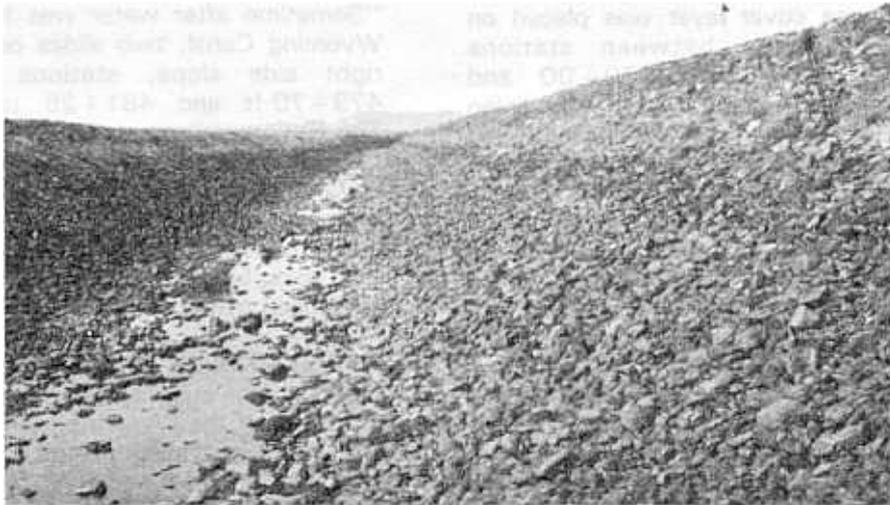
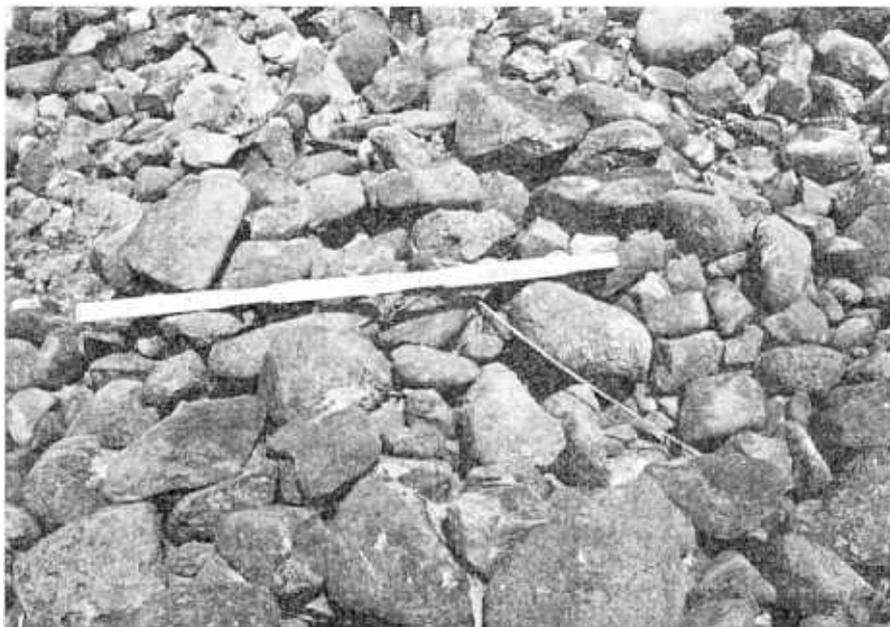
When inspected in October 1977 [2], this cover was in very good condition (fig. 25).

Figure 25. -- Helena Valley Canal, looking downstream from station 92 + 45 m (303 + 30 ft) (top) and cover surface at station 92 + 66 m (304 + 00 ft). March 1978 Photos P801-D-79555 and P801-D-79527

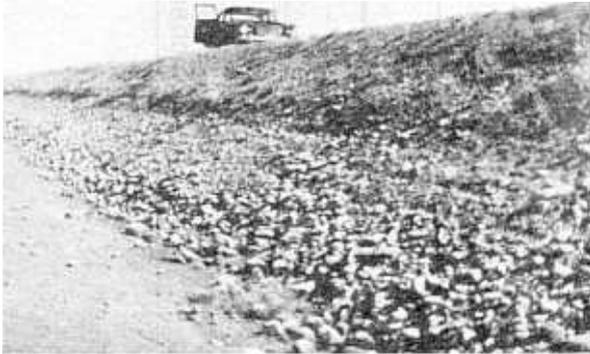
When samples of the coarse cover layer were obtained in June 1961, the cover was reported to be in excellent condition. A 1962 photograph of the cover is shown in figure 27. When inspected in March 1978, it was rated as good. There was some sloughing on the upper levels of the south slope. The manager of the Arch Hurley Conservancy District believed that the removal of woody vegetation had caused the sloughing in isolated spots. At station 146+00 m (479+00 ft), there was a sloughed area about 9 m (30 ft) long that could have been caused by wind-wave action.

Figure 27. — View of gravel blanket material on the right slope of Hudson Canal at station 145+05 m (475+89 ft). February 1962 Photo P801-D-79526

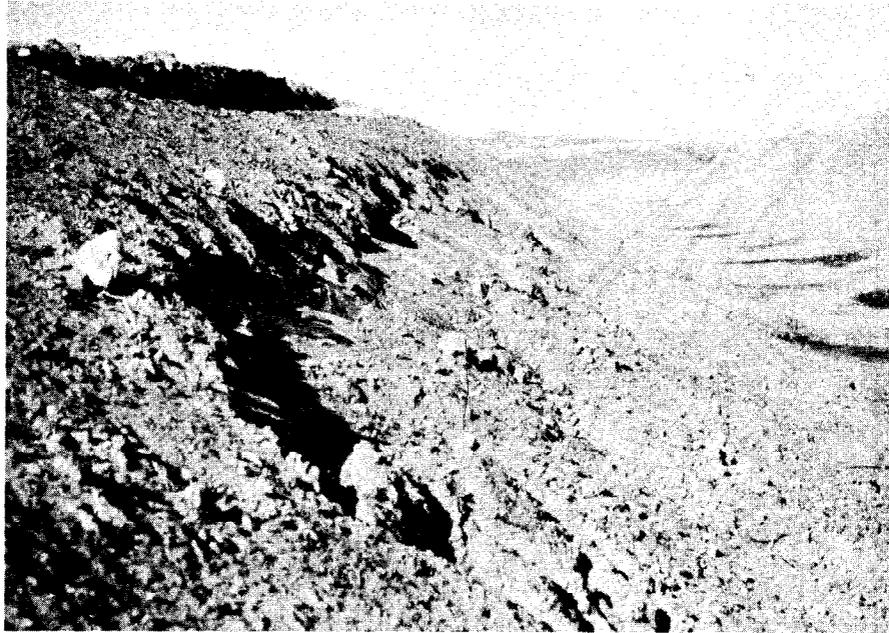
On February 15, 1977, a slide occurred on the PVC-lined right bank of Pilot Canal of the River-ton Project, Wyoming, between stations 185+93 and 186+54 m (610+00 and 612+00 ft) (fig. 29). This section of canal has a water depth of 3.1 m (10 ft), bottom width of 9.1 m (30 ft), and 2:1 side slopes. The 250- μ m (10-mil) thick lining was placed in November 1976 to replace deteriorated asphalt membrane lining. The cover over the membrane consisted of 225 mm (9 in) of soil from canal excavation superimposed with 225 mm of pit run gravel.

For a major portion of the slide, slippage occurred between the membrane and the soil underneath, and the membrane was torn in places. Observations of an adjacent section of lining, soon after the slide, revealed ice under the lining. Also, for about a 50-mm (2-in) depth under the lining, there was a series of ice lenses about 1 to 3 mm (1/16 to 1/8 in) thick, alternating with layers of soil; this is typical of frost action in soil. The soil beneath the membrane was a sandy clay with a liquid limit of 37 and a plasticity index of 19. Ninety-six percent of the soil particles passed the No. 4 sieve, 90 percent passed No. 40, 60 percent passed No. 200, and 25 percent was finer than 0.005 mm.

There was no water table under the lining sufficiently near the canal surface to have caused open-system frost action. Apparently, as frost penetrated into the subgrade, moisture migrated upward and froze at and in thin lenses immediately below the plastic lining barrier. The record of daily temperatures in the general area showed an unseasonable warming trend for a few days prior to the slide, with a maximum temperature of 13 °C (55 °F) which probably caused thawing to depths immediately below the plastic membrane. Melting water would be trapped between the membrane and frozen material below, and the resulting lubrication seems to be a plausible explanation for the cause of the slide.

Figure 29.—Slippage of PVC membrane lining on Pilot Canal, stations 185+93 to 186+54 m (610+00 to 612+00 ft). February 1977 Photo P801-D-79547

Previous to the slide, the subgrade was lightly rolled to form a smooth surface to avoid puncturing the plastic by rock particles. Current specifications provide for dragging the subgrade surface with the removal of projecting particles likely to cause puncturing. Also, a 50-mm (2-in) thick sand layer of unspecified gradation may be applied at the option of the contracting officer. These measures are intended to provide more frictional resistance to sliding.

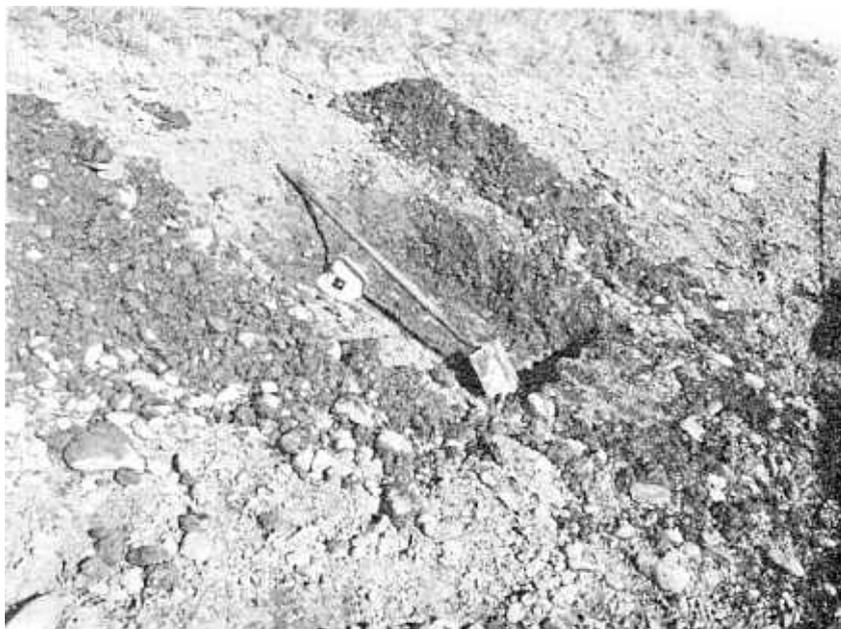
Figure 32.—East Bench Canal. Excavation through single layer of gravel cover to PVC membrane at station 412+58 m (1353+60 ft). October 1977 Photo P801-D-79546

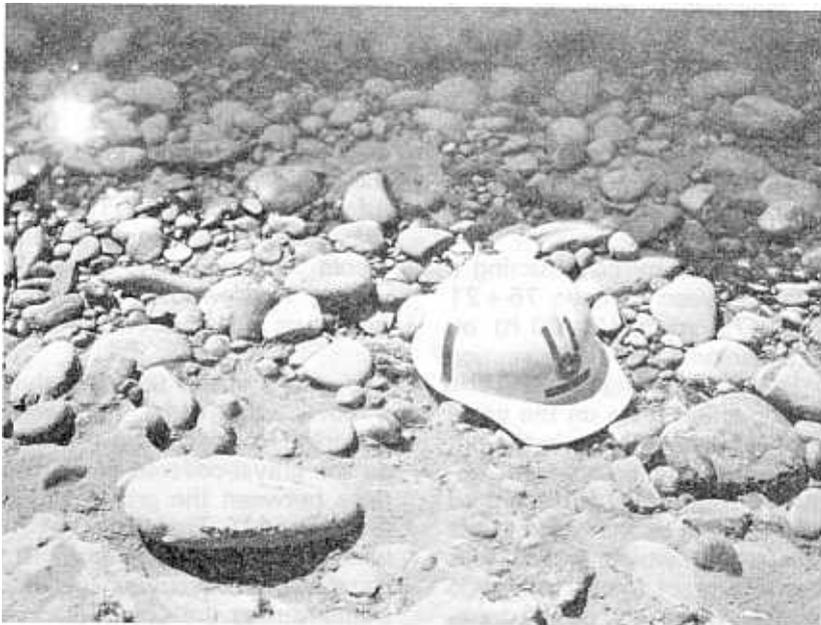
Figure 35.—Amarillo Canal. Typical slope condition at station 123+14 m (404+00 ft) in section 4A. August 1980 Photo P801-D-79544

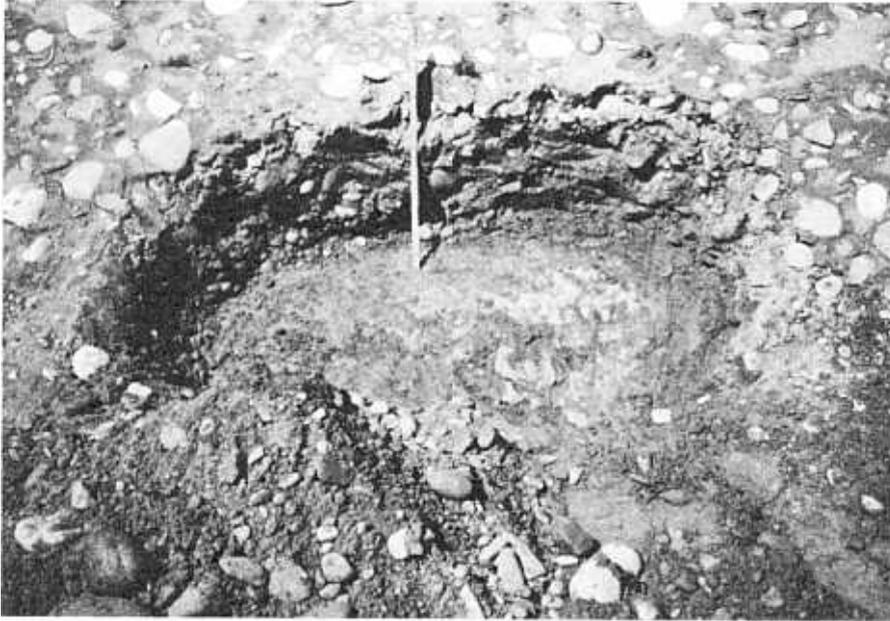
Figure 36.—Cover and exposed membrane on Amarillo Canal. Photo P801-D-79543

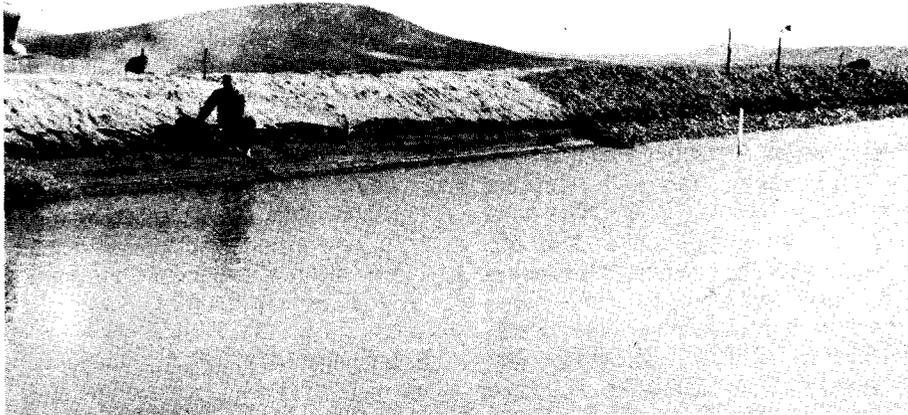
Figure 40.—The difference between erosion of compacted canal embankment with and without a single layer of gravel cover. Kennewick Main Canal test section. March 1954 Photo P801-D-79542

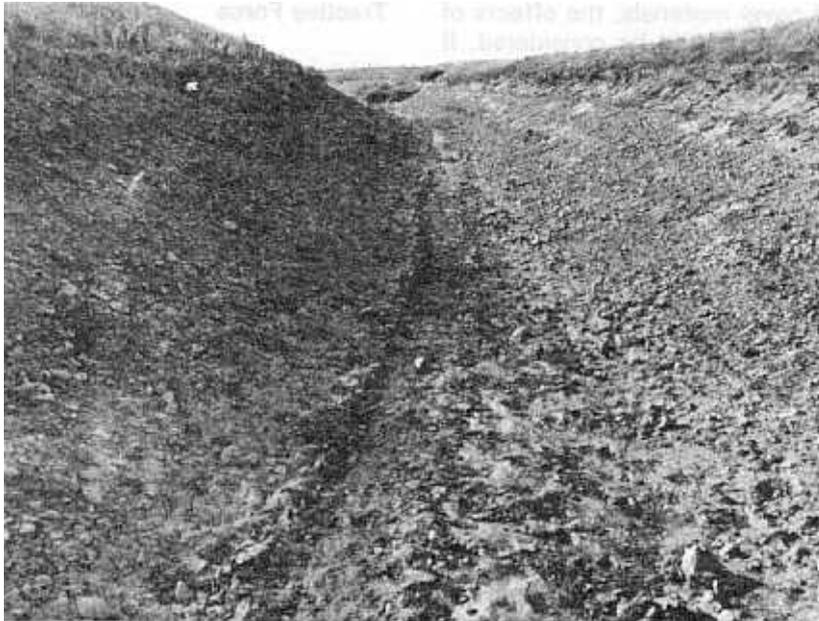
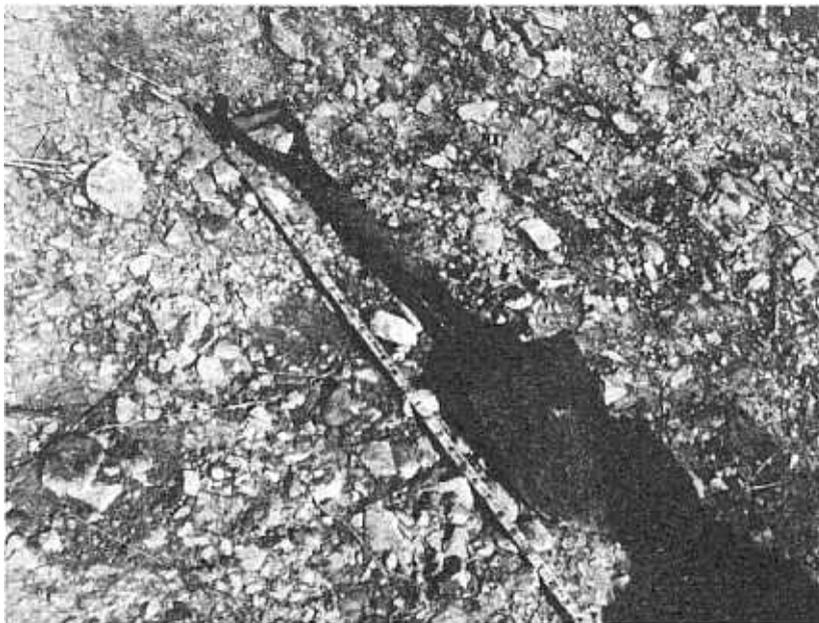
When the cover was inspected in January 1978, it was rated in good condition. The measured depth of cover was 75 to 125 mm (3 to 5 in). Photographs of the canal obtained at that time are shown in figure 46.

Figure 46.—Distant (top) and close views of the cover on Upper Meeker Canal.
January 1978 Photos P801-D-79548 and P801-D-79552
